Castle Community Centre Rain Garden

1. Location

Castle Community Centre, Barbers Lane, Northwich CW8 1DT

2. Description

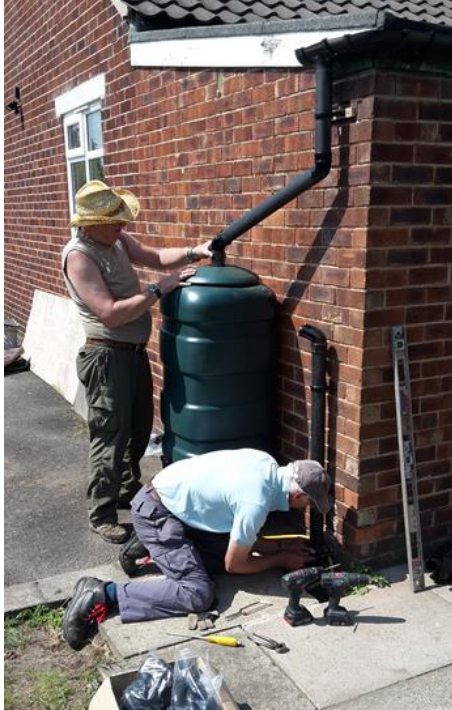
1. Crewe Conservation Volunteers install the water butts

The first part of the system to be installed was a series of four water-butts; one at each of the downpipes from the guttering around the roof of the single storey community centre building. These enable collection of rainwater for use in watering the centre's developing garden, and when full, overflows into a buried pipe network, which carries water to the excavated raingarden.

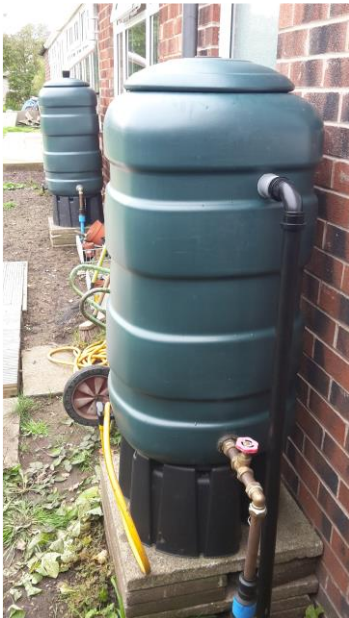
2. Water butts showing isolation valves and overflow pipe to raingarden

Three of the water butts are connected together by buried pipework and isolating valves, which enable these to be drained down individually or as a single unit providing a greater head of water and increased water pressure for use via hosepipes around the garden.

- A surveyors optical level and ranging pole were used to ensure that a fall of 1:100 was maintained along the length of the pipework to ensure sufficient flow to prevent siltation.
- Silt is also prevented from entering the system at the earliest stage as the waterbutts themselves act as effective silt traps, with water overflowing into the system only from the top of the waterbutt, while any silt will safely accumulate at the bottom.

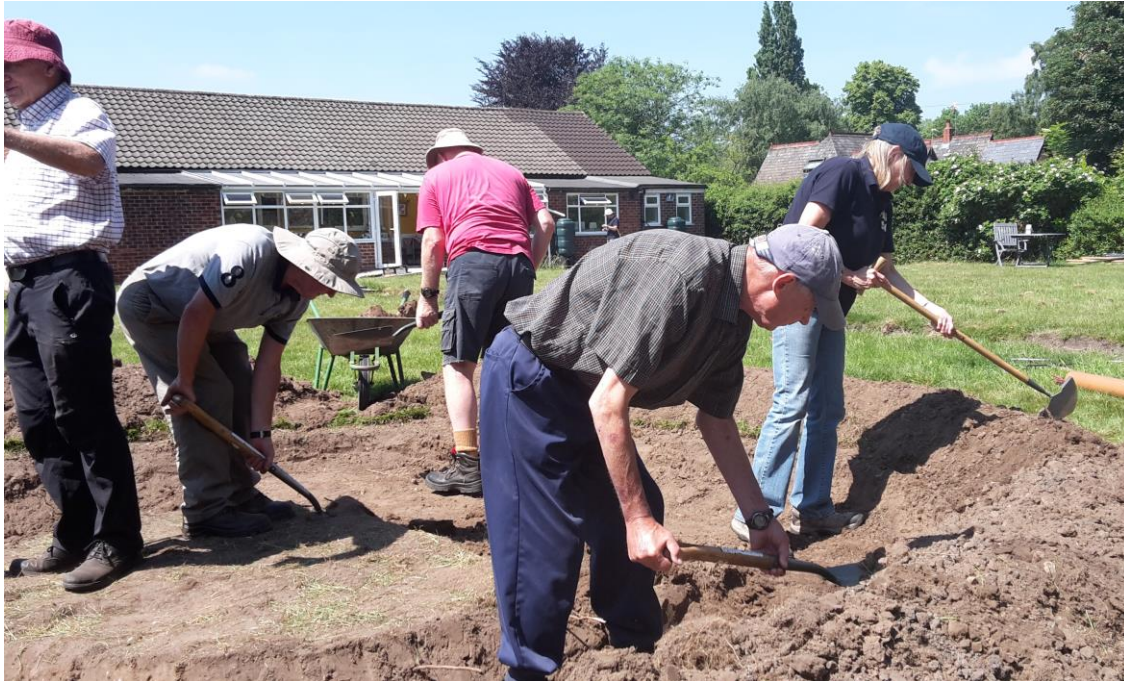
3. Vale Royal Conservation Volunteers excavate the rain garden

The raingarden was excavated by hand in free draining sandy subsoil to a depth of approximately 60cm. A bund approx. 20cm high was created around rim of the excavation to provide extra capacity and avoid flooding of surrounding areas in periods of extreme rainfall.

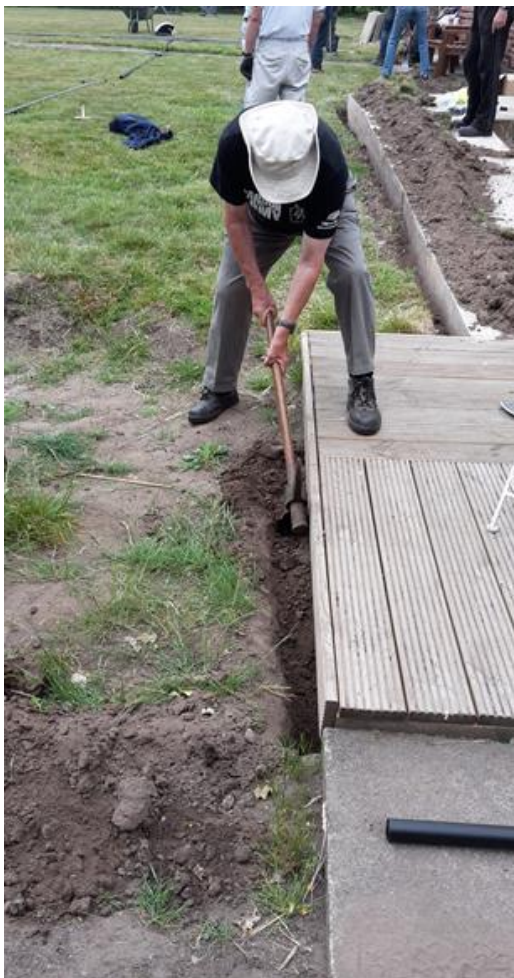
4. Vale Royal Conservation Volunteers excavate the pipe trenches

Prior to backfilling, trenches were dug and pipework installed, using easy-to-install black plastic 40mm waste pipe with pushfit connectors.

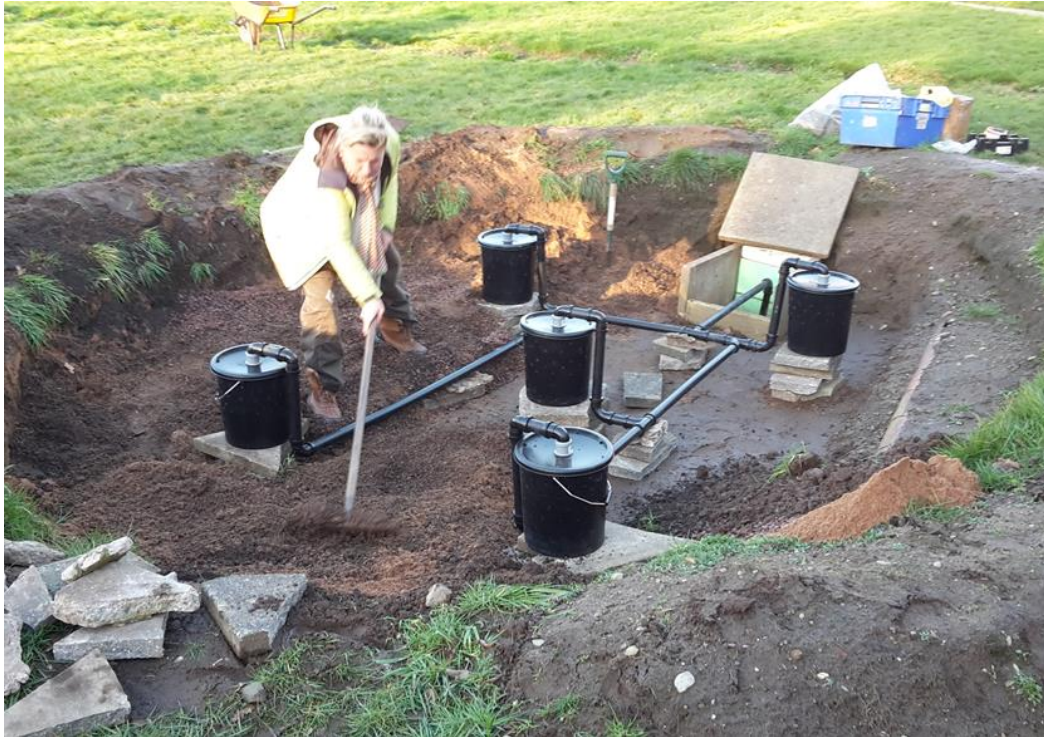
5. Love My River Volunteers installing five-point outfall and silt-trap buckets

- As it enters the raingarden, the pipe carrying rainwater from the waterbutts passes through an inspection chamber which allows for dismantling of the pipework at its lowest point, enabling flushing and de-silting if required.
- From this point the pipe divides into five branches, each branch having its own outfall. This also enables water to be more evenly distributed around the excavation. Each outfall empties into a bucket which has a series of drainage holes drilled into the sides of the buckets at regular spacings between the top and half way down. This enables any silt entering through either the outfall pipe or the drainage holes to settle at the bottom of the bucket.
- Before final back-filling, the buckets were wrapped with a geotextile material cable tied into place to reduce the likelihood of silt entering through the drainage holes.

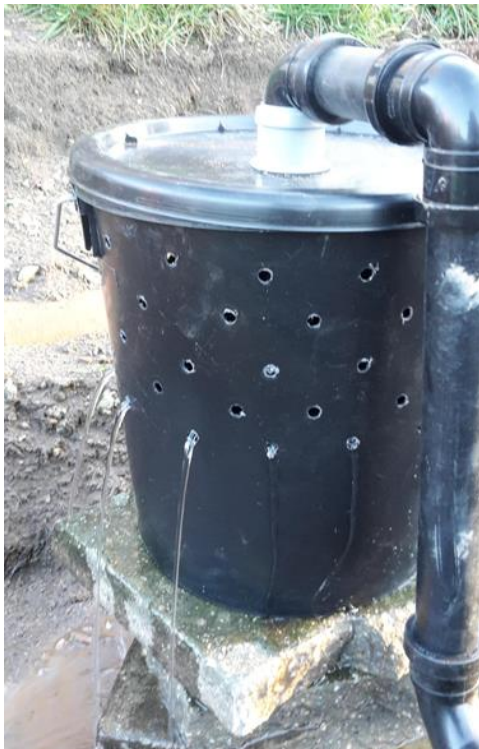
6. Testing silt-trap buckets being for water-flow

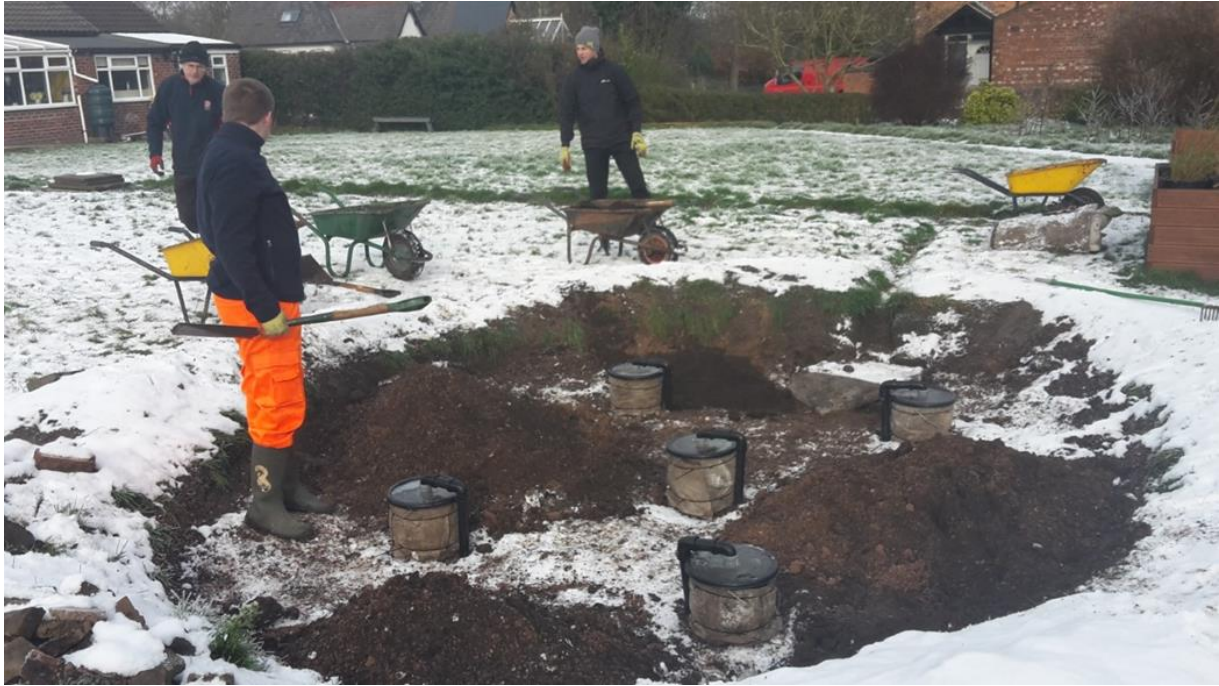
7. Grozone volunteers wrap buckets with geotextile and complete rain garden back-fill

Back fill material for the rain garden consisted of a combination of sand, compost and subsoil, to create a free draining substrate containing enough organic matter to hold in moisture around plant roots during dry spells. Final planting included a range of native wetland and marginal plants, together with some annual wildflower seed for early colour. The bund around the excavation was seeded with an amenity grass seed mix.

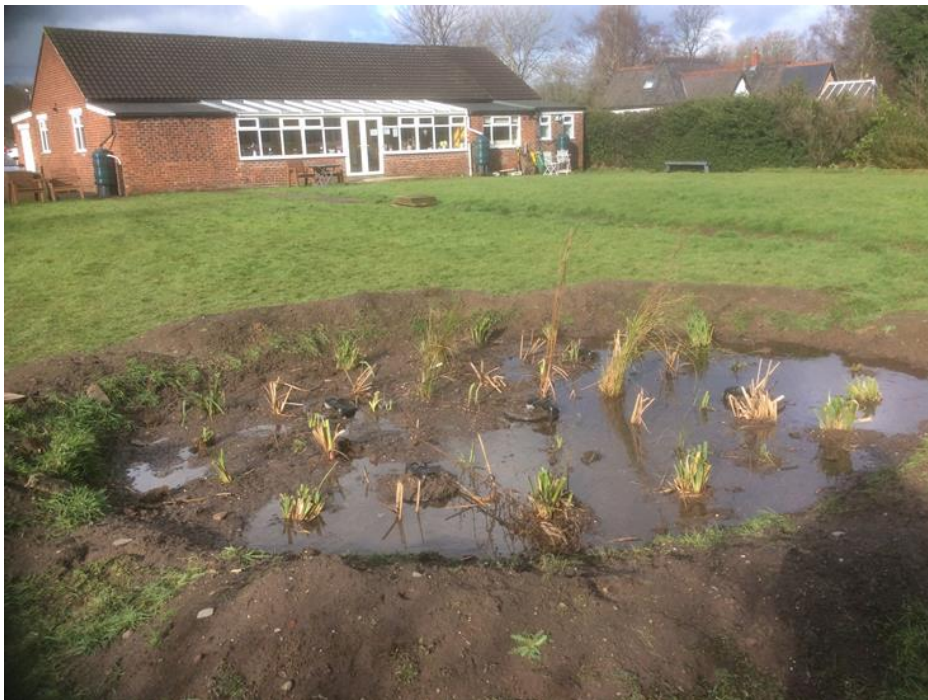
8. Completed rain garden shown soon after planting, the day after a night of heavy rain.

The completed rain garden now acts as an effective soakaway for the rainwater from the community centre roof and has been observed functioning well during periods of extreme rainfall. At the same time, the raingarden provides valuable seasonally wet habitat for wildlife, including pollinating insects.
