# Glenbrook Wetlands, Enfield

## SuDS used

## 2. Description

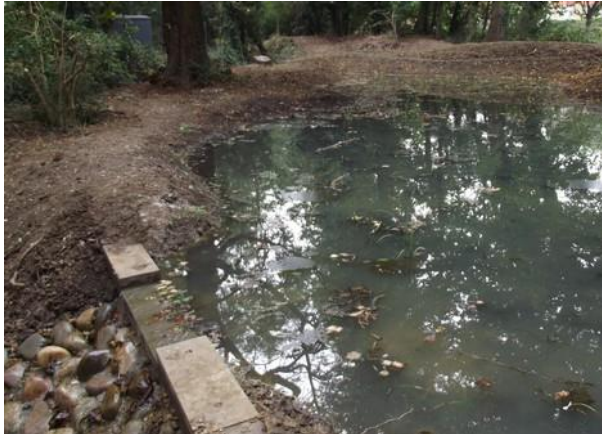
Figure 1 Impact of misconnections

Misconnected plumbing contributes phosphates, nitrates and coliform bacteria etc., road run-off inputs oils and heavy metals such as zinc and copper, and household and industrial waste is dumped into surface water drains. This pollution is particularly evident during dry periods when there is little rain to dilute misconnection flows (see figure 1).

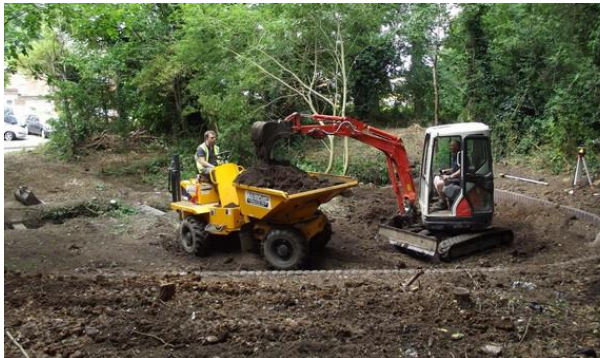
Figure 2 Construction of wetland

The works improved the woodland's ecological value by opening up the canopy in this wooded area, re-naturalising the stream banks, providing new wetlands and improving the water quality (see figure 2). Therefore as well as an increase in wetland biodiversity, ground flora and associated species have become more diverse.

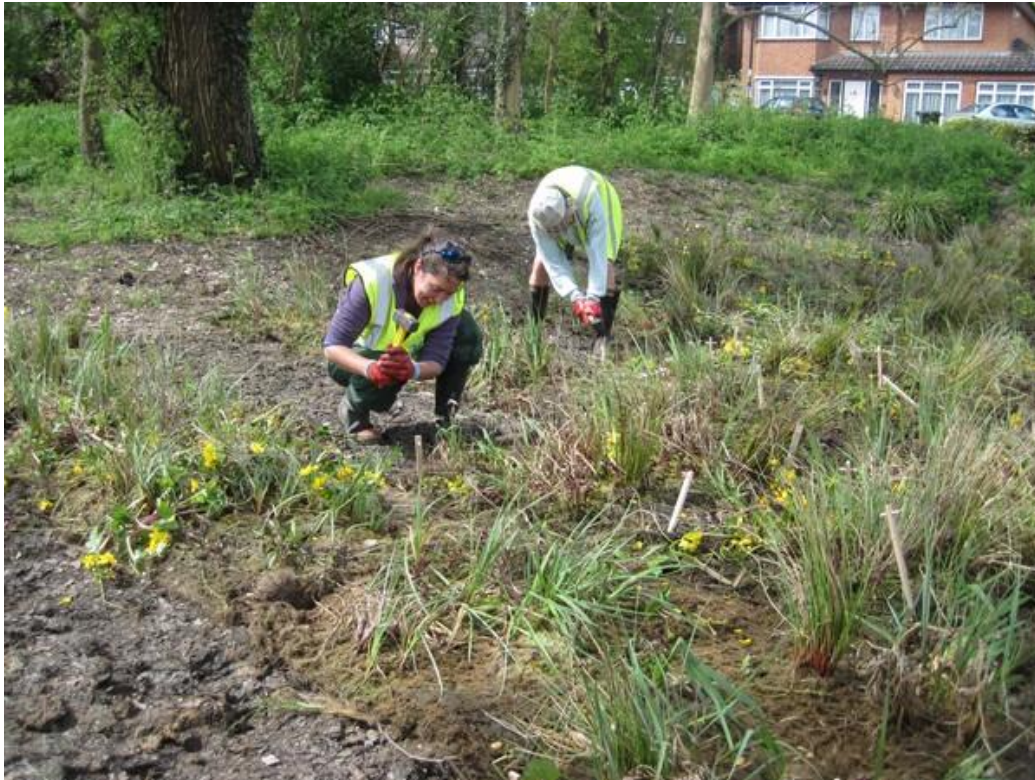
Figure 3 Volunteers planting SuDS components

The wetland basins that collect and treat polluted runoff are very similar to naturally occurring wetlands and are maintained in the same way. This is the responsibility of Thames21 who have worked with dedicated local volunteers to establish and control vegetation and clear litter when necessary (figure 3).

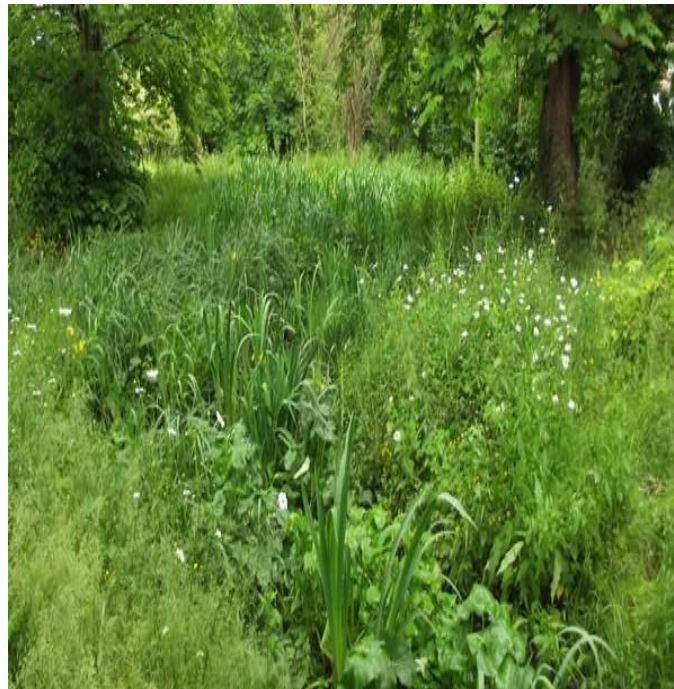
Figure 4 Completed project

At the start of the project Glenbrook was an area of thick woodland choked by bramble and fly-tipping, attracting anti-social behaviour. The stream was hidden away, heavily polluted and unloved. Now the site has new attractive features of a chain of wetlands enveloping a cleaner stream. Opening the tree canopy has allowed more diverse ground flora to flourish and already new species are seen visiting the area. It is much more welcoming and a safer place to be (see figure 4).
