Houndsden Road Rain Gardens, Enfield

SuDS used

- Swales
- Rain gardens

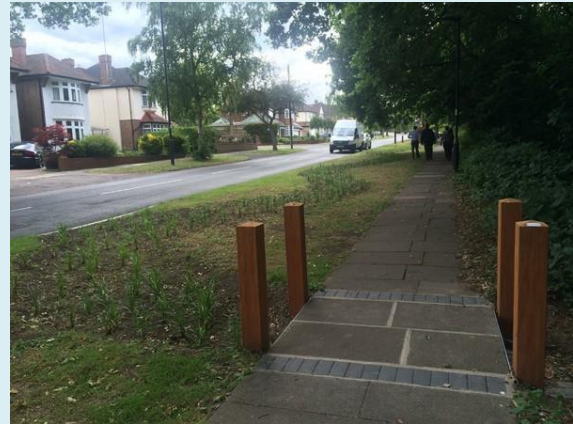
In the first rain garden runoff is directed along the verge in a shallow swale and into the natural woodland basin of the spinney, where chemicals which would pollute the river are filtered out and broken down by biological processes within plants and the surrounding soil. The swales have been planted with sedges and native grasses to slow water flow and begin the treatment, and the woodland basin planted with suitable native seed mixes. Water will then naturally soak into the soil, recharging the water table. This is particularly important during times of summer drought.

The second rain garden system works in the same principle, diverting road runoff through swales and two planted basins, with capacity for an overflow route during times of very heavy rainfall.

A second kerb inlet joins the swale before running underneath the pavement beneath a shallow pavement bridge (figure 2). It then continues into a natural woodland basin which is planted with a woodland seed mix. Some small trees were removed here in consultation with the council’s Arboricultural Officer. The water is slowed and treated in both the swale and the woodland basin before infiltrating to help recharge groundwater.

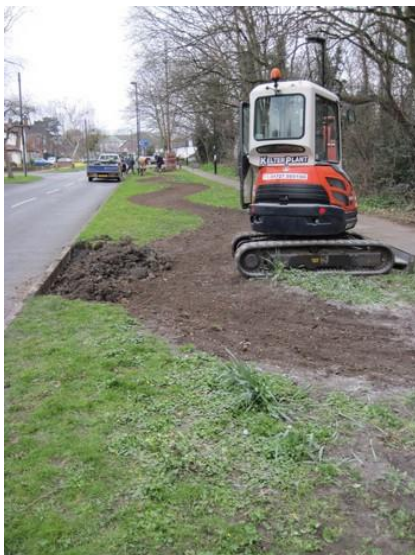
Figure 1 Constructing the swales

In phase 1 a gully was filled and the kerb lowered to create an inlet, taking care to ensure this was situated some distance away from utility installations. The inlet allows runoff to flow into a treatment swale meandering through the grass verge, planted with pendulous sedge. See figure 1 of the construction.

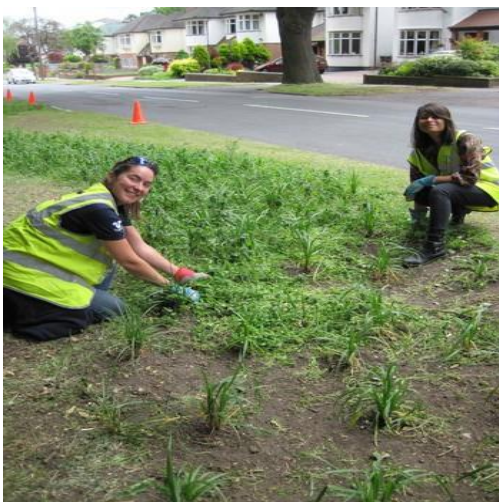
Figure 3 Volunteers weeding the swale

The swales and woodland basins require occasional vegetation management approximately once or twice per year. This is the responsibility of Thames21 who have worked with dedicated local volunteers to establish and control vegetation and clear litter when necessary (see figure 3 of volunteers weeding the swale).
