Walking the Talk! Whitby Retrofit

9 Westbourne Avenue, Whitby, North Yorkshire, YO21 3NF

The existing combined system property drainage configuration gave the designer a number of challenges, which this innovative and bespoke solution elegantly overcame. As a flood risk and sewerage professional, the client (and designer!) also had a keen professional interest in making sure that the property alterations made a positive contribution to managing water in the catchment!

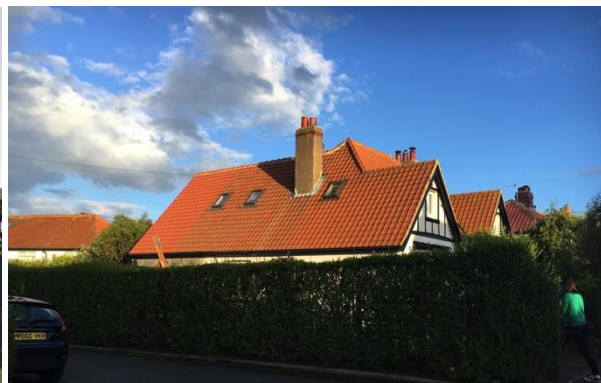
Extended property

The design of the rear extension added a new gable end to the North East quadrant of the building, severing the connection to the rear drainage for a substantial portion of the existing and the new roof area.

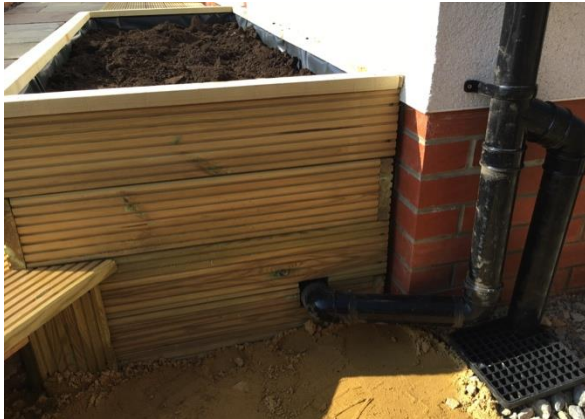
Downpipe connection to raised bed & overflow

Flow from the roof is collected by a traditional gutter and downpipe, which then runs into the bottom of a series of raised beds, inter-connected by perforated pipework surrounded by a single-size gravel medium. Vertical wicks run through a barrier layer into the soil to facilitate the drawing up of moisture into the soil. The beds are all lined with a waterproof membrane, and an overflow ensures that the level in the beds doesn't waterlog the upper layer of the growing medium.

The overflow is connected to a rubble-filled trench. Though trench is substantial, the local clay soil meant that this would not have been sufficient without the additional capacity offered by the raised beds.
