Firs Farm Wetlands, London

2. Description

3. Main SuDS components used

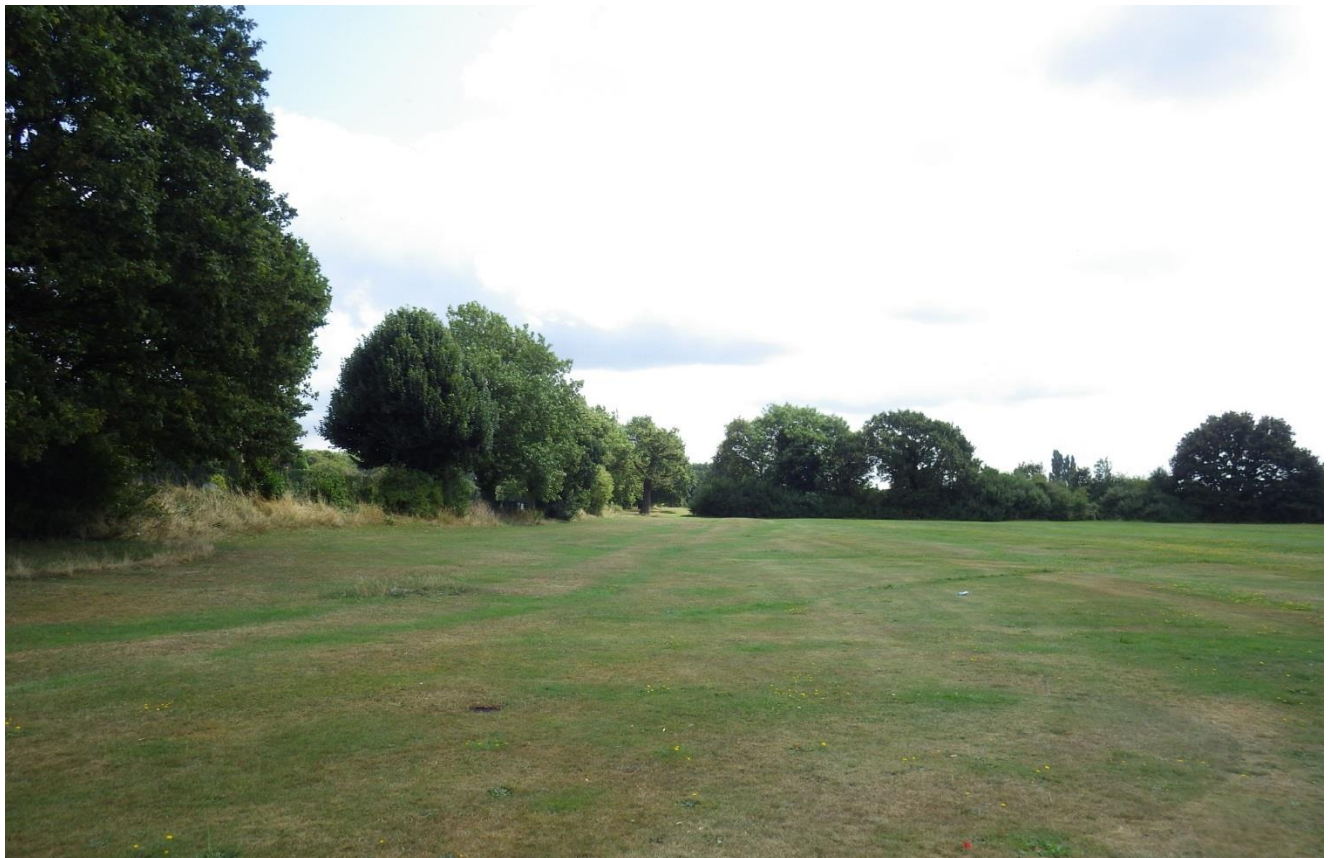
Figure 1 Firs Farm Site prior to implementation

Firs Farm Playing Fields is permanently open to the public. Prior to the wetland works the site was used for sports pitches, none of which have been removed as the design of the scheme sits outside their boundaries. The other main users of the site were dog walkers, with the only formal path in the site being located some distance to the south. All of the pedestrian entrances to the site were unwelcoming and even unsafe. The site was not realising its potential given its size and location. The only ecological variances across the site other than open grass were some wooded copses.

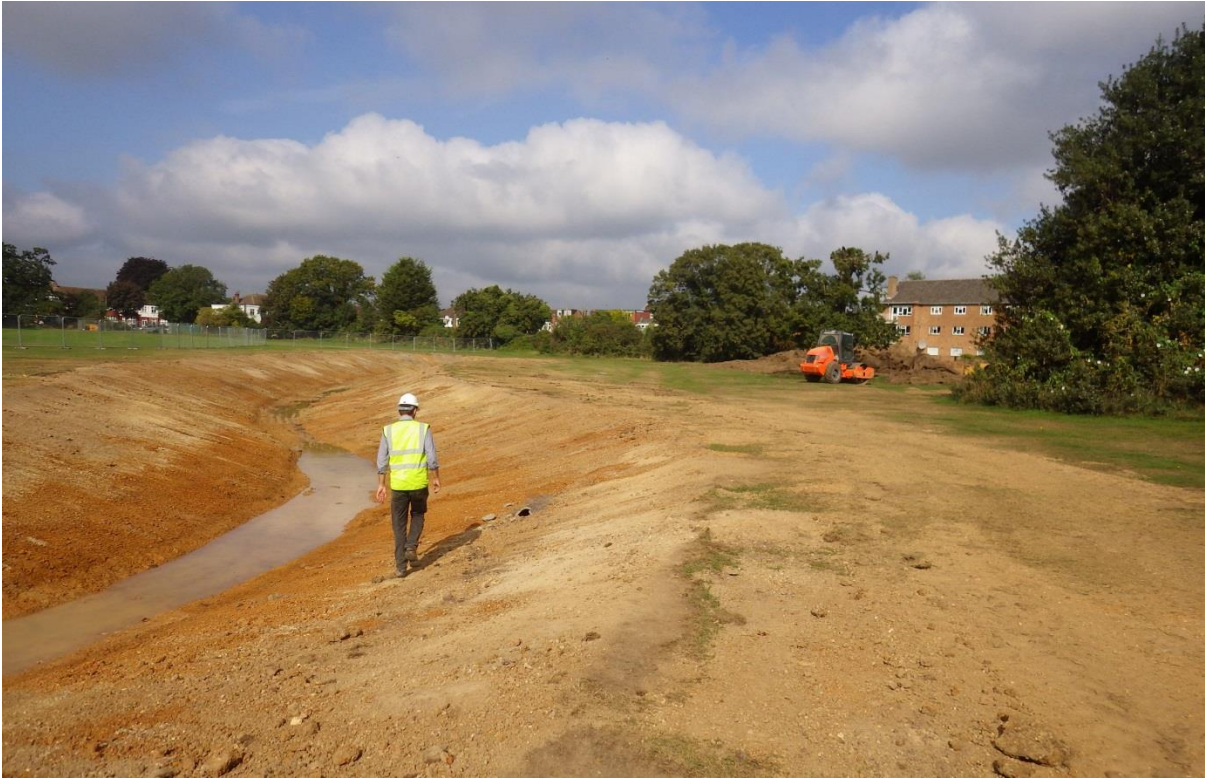
Figure 2 Firs Farm Site after completion of Phase 1

Phase 1 of the scheme involved excavating the footprint of a new 500m long open watercourse with an average depth of 1.5m. Excavated spoil from the new channel was used to create a natural earth flood bund along the eastern boundary of the site. This ensures that flood water is stored on the playing fields during extreme rainfall events, increasing protection to nearby houses. The new flood

storage area is below the threshold of a statutory reservoir (25,000m³). Nevertheless it was constructed to the required standard for an asset of this status in strict accordance with methodology approved by a Qualified Reservoir Engineer; this included the appropriate degree of compaction and testing of the suitability of the material. This was to ensure that the new feature is safe for local residents

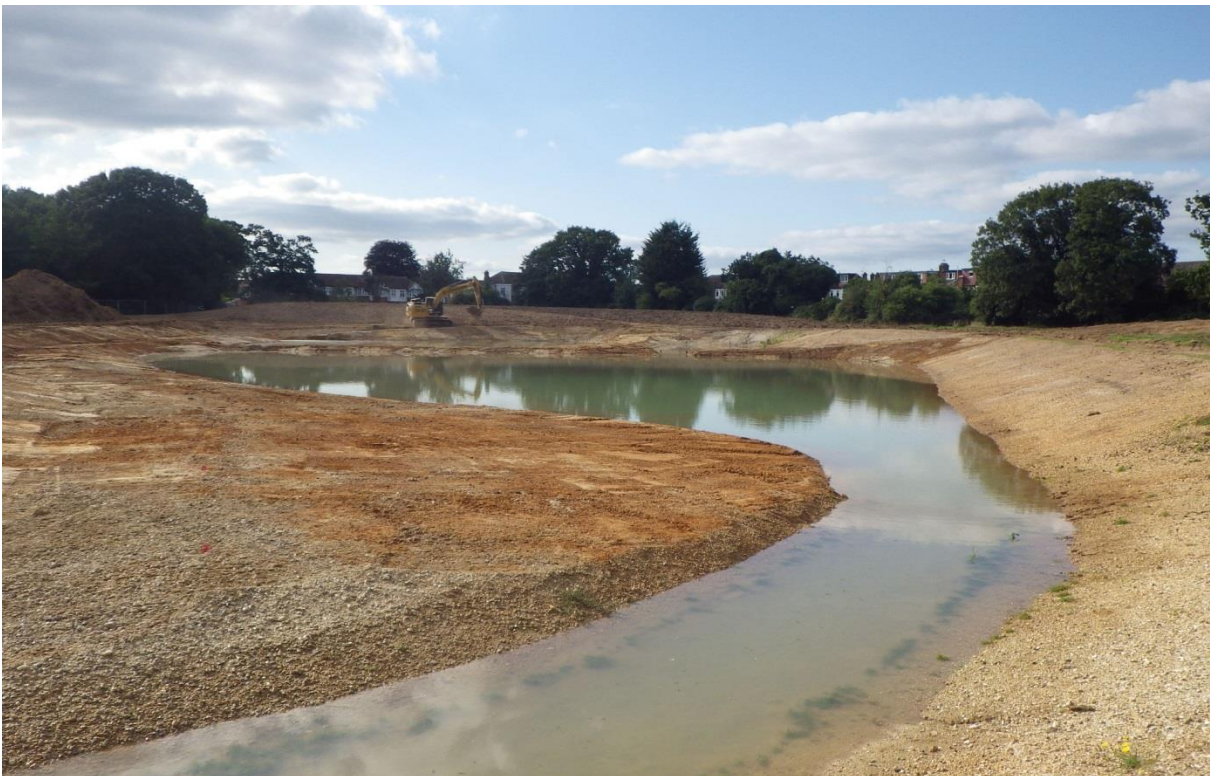
Figure 3 Construction of wetland cells

The wetlands cells have been designed to incorporate different slope gradients, depths and levels of planting. Some areas around the wetland margins have been densely planted whereas others have been left to regenerate naturally. Water depths within the wetlands are typically 0.2 – 0.3m for dry weather flow. Some open water pond features have also been created by increasing the depth to 1.0m at selected locations to collect silt and allow for a change in planting.

Given that the presence of the scheme was likely to attract a greater number of users to the site a wider consideration of the public health and safety was required during the design. The gradients of the slopes of the wetland cells are designed to have a maximum fall of 1 in 3 for example.

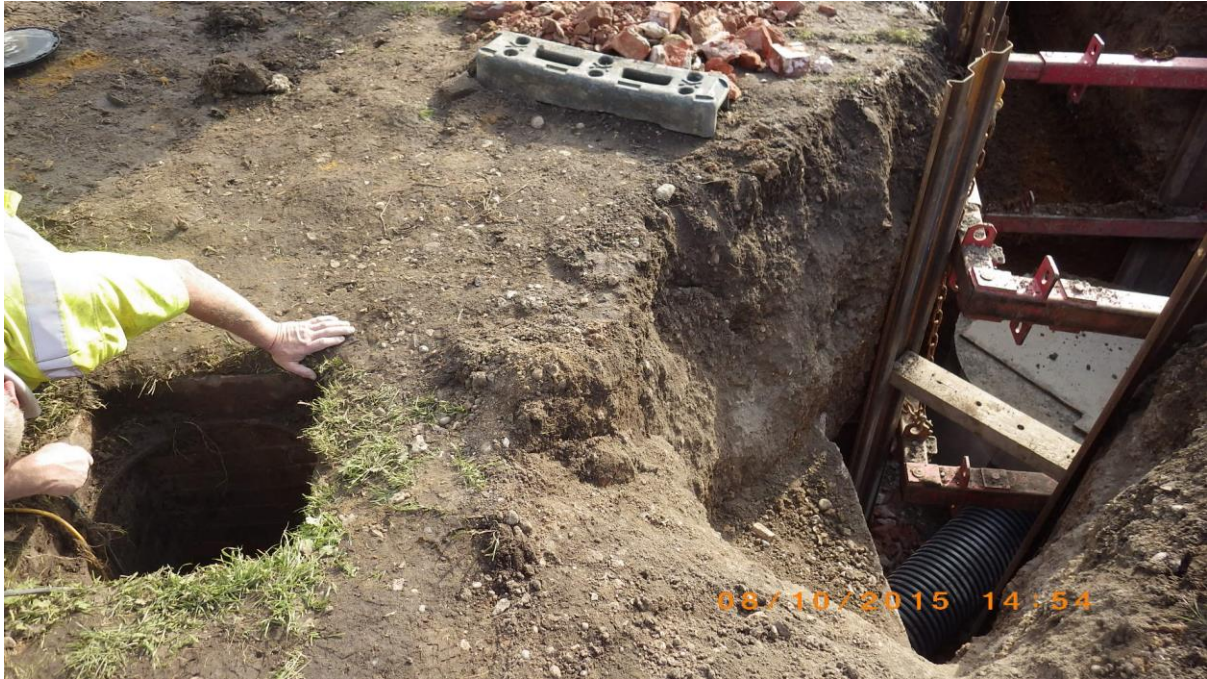
Figure 4 Constructing a new outfall

It was also necessary to construct an outfall structure at the downstream end which directs the above ground flows back into the original culvert. This outfall is an in-situ concrete headwall, with the connecting pipes sized appropriately to discharge flood water held back by the bund.

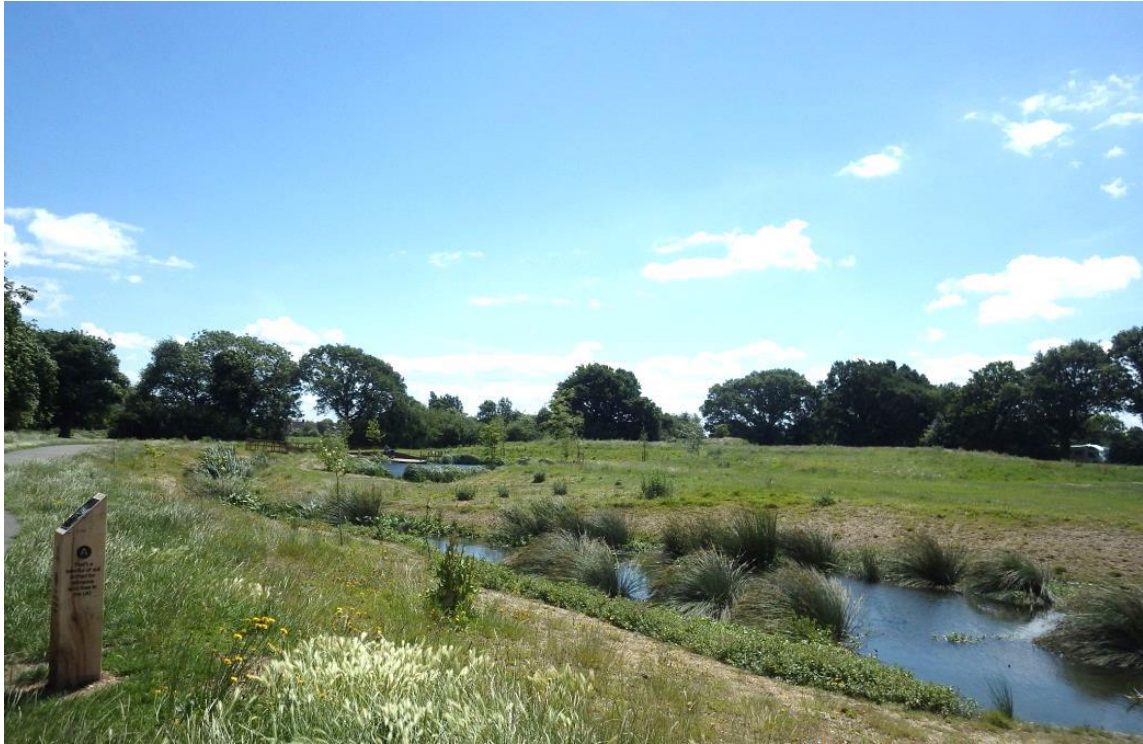
Figure 8 Overlooking the de-culverted watercourse and ponds from the same vantage as figure 1

The scheme involved restoring 500m of the Moore Brook, a 'lost' tributary of Pymmes Brook which is itself a tributary of the River Lee. The spoil from the newly excavated channel was used to create a 200m long flood defence that forms the eastern boundary of the site.
